**DEBRIS/ICE/TPS ASSESSMENT and
INTEGRATED PHOTOGRAPHIC ANALYSIS
OF SHUTTLE MISSION STS-108**

Armando Oliu
Process Engineering/Mechanical System Division/ET-SRB Branch,
Kennedy Space Center, Florida

December 5, 2001

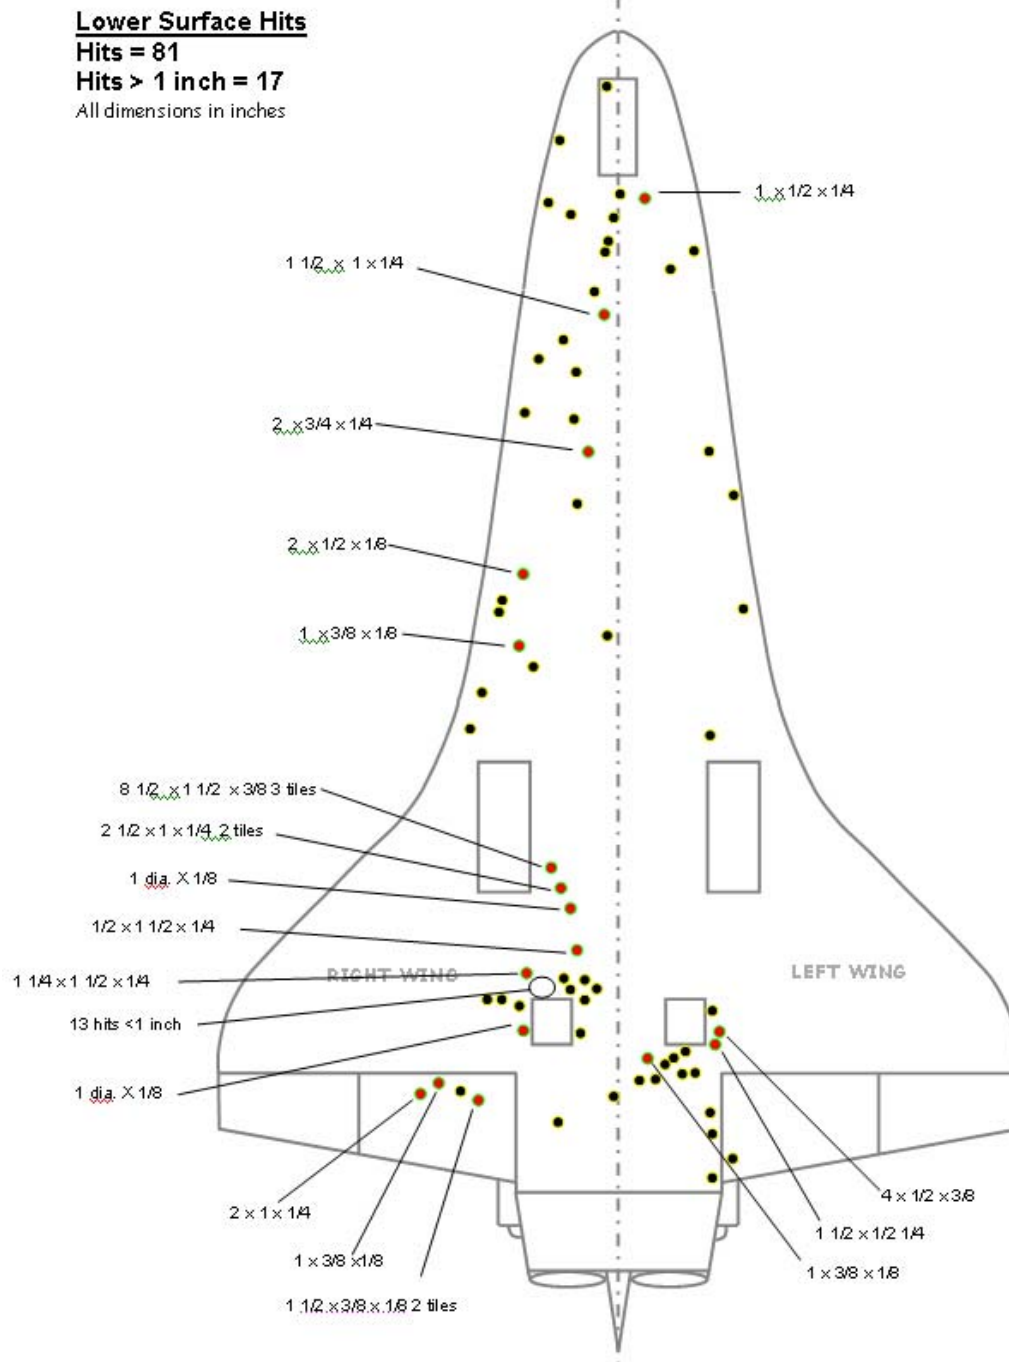
Figure 1: Orbiter Lower Surface Debris Damage Map

Post landing inspection of Orbiter tiles showed a total of 95 hits, of which 22 had a major dimension of 1-inch or larger. The Orbiter lower surface sustained 81 total hits, of which 17 had a major dimension of 1-inch or larger, both numbers are within family. The majority of the hits (49 total with 12 greater than 1-inch) were located in the area aft of the main landing gear wheel wells. Most of these damage sites around the ET/ORB umbilical were most likely caused by pieces of the umbilical purge barrier flailing in the airstream and contacting tiles before pulling loose and falling aft.

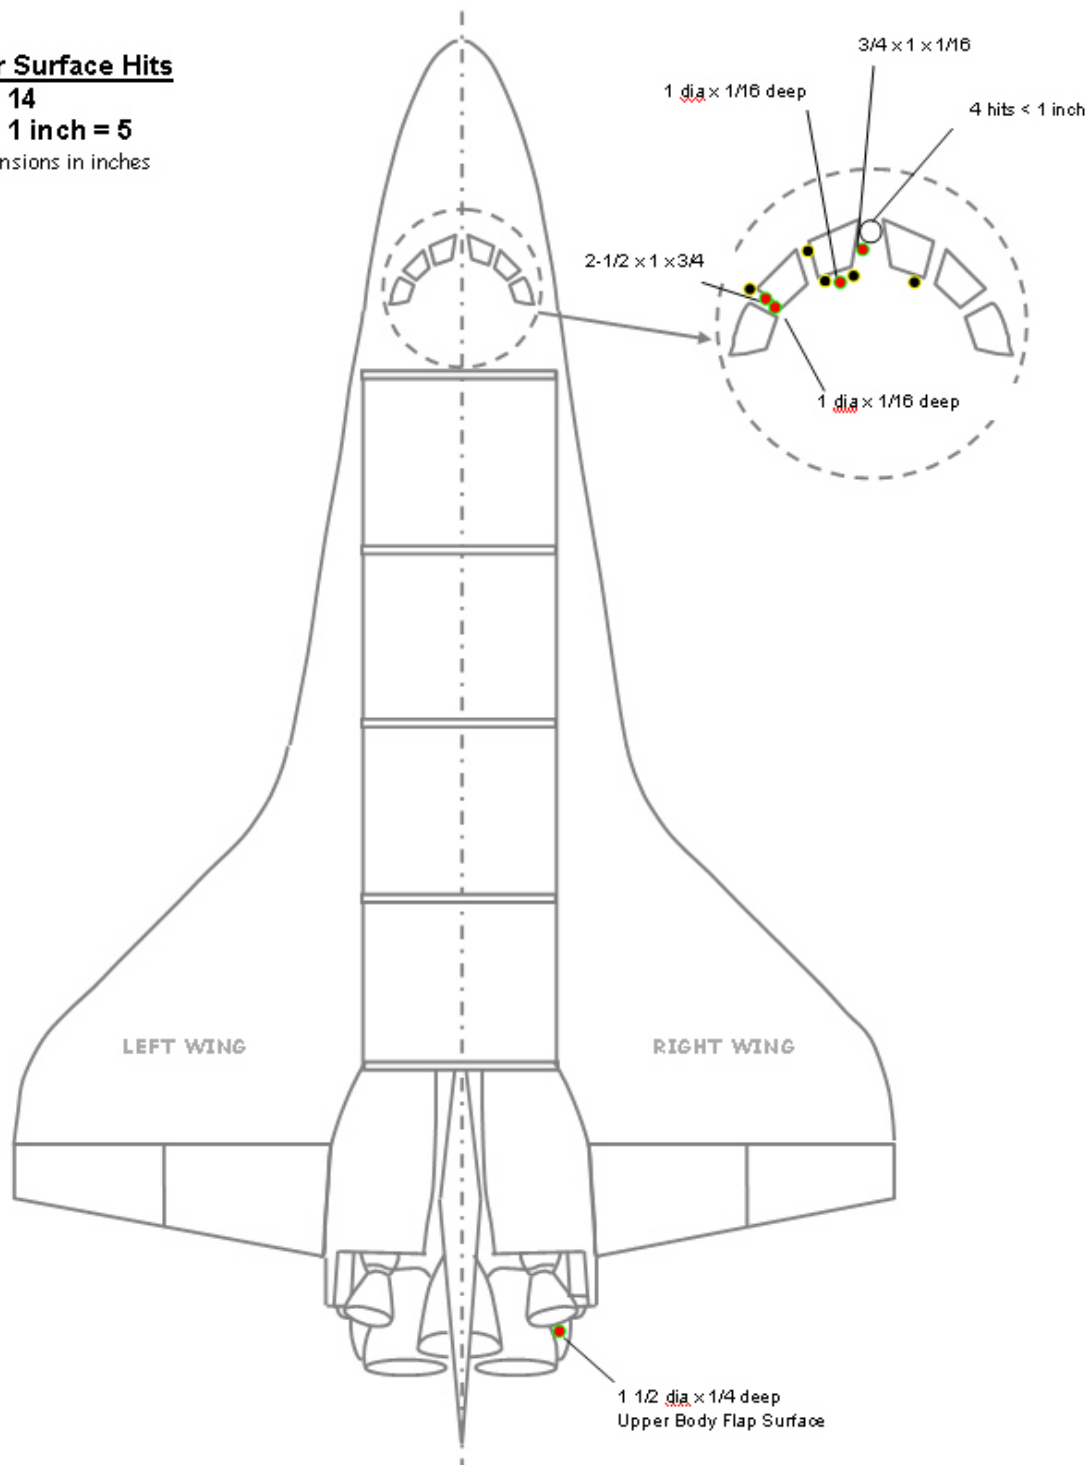
Figure 2: Orbiter Upper Surface Debris Damage Map

Hits > 1 inch = 5

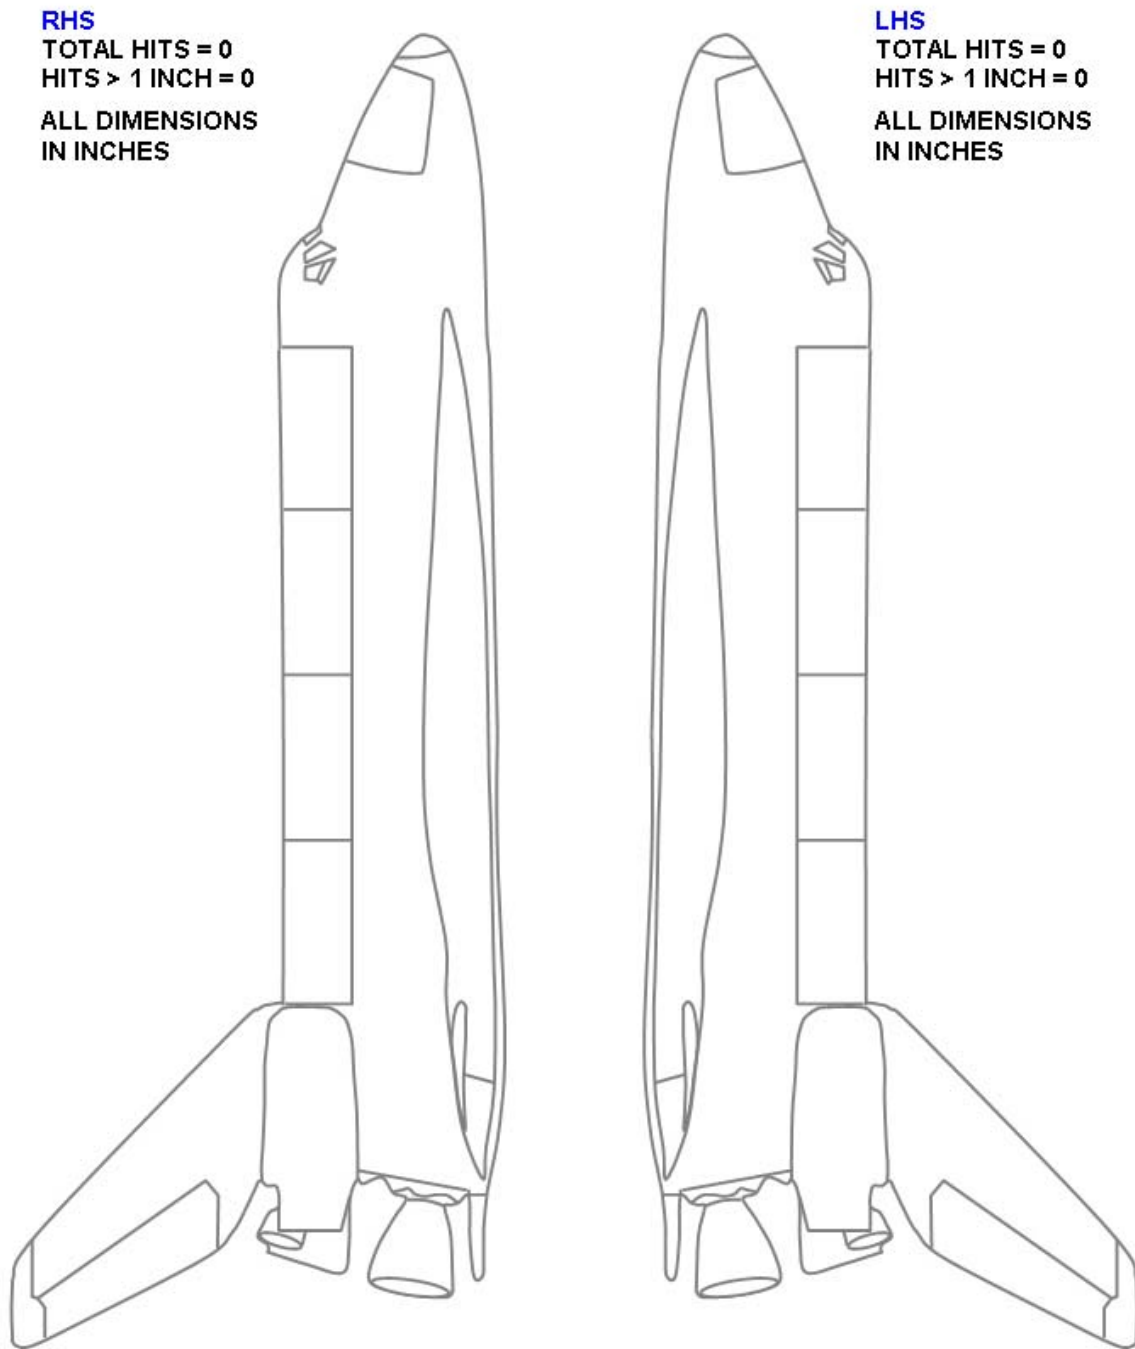
Figure 3: Overall View of Orbiter Sides

The Orbiter TPS sustained a total of 95 hits of which 22 had a major dimension of 1-inch or larger. Both the total number of Orbiter TPS debris hits and the number of hits 1-inch or larger were within established family.

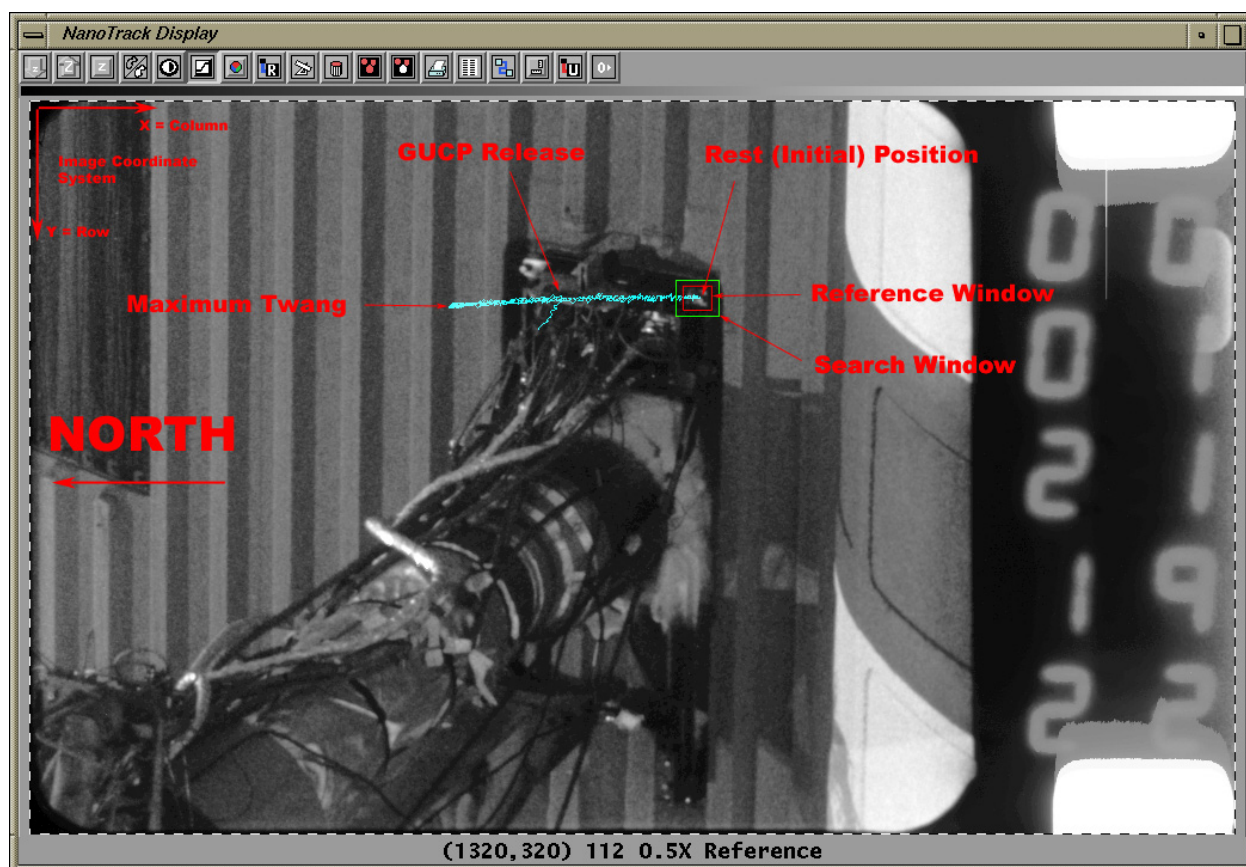
Figure 2.1.3 (A) View of GUCP (Camera E33)

The Space Shuttle Systems Integration Team requested a comparison of the imagery from camera E-33 from STS-108 and selected previous launches. After a review of which additional cameras contained views that might contribute information about the behavior of the vent arm, the imagery from camera E33 for STS-108 and selected previous launches was analyzed. See Figure 2.1.3 (A). Camera E-33 is a 200 frame per second high speed 16mm motion picture camera mounted on the FSS. The camera was positioned about 68 feet from the GUCP, looking slightly down and South of East. The camera had a 100 mm focal length lens and provided an excellent view of the GUCP at launch. During main engine start, the forces from the engines force the vehicle stack to sway (the Twang maneuver). At the level of the GUCP, the stack sways about 20 inches to the North and rebounds about 9 inches before the SRB's (Shuttle Rocket Booster) ignite. At SRB ignition the GH2 vent arm disconnects from the External Tank and swings down away from the vehicle (pivoting around a shoulder joint where it attaches to the FSS) to its capture position within the FSS while the vehicle accelerates upward. The entire horizontal motion of the GUCP during the Twang is within the field of view of the camera. During the disconnect the GUCP first released at the top, pivoted out around its feet which were standing on two small shelves projecting from the ET, and then fell vertically once the feet had been dragged off their shelves. Soon after the GUCP disconnects from the ET, it exited the bottom of the field of view.

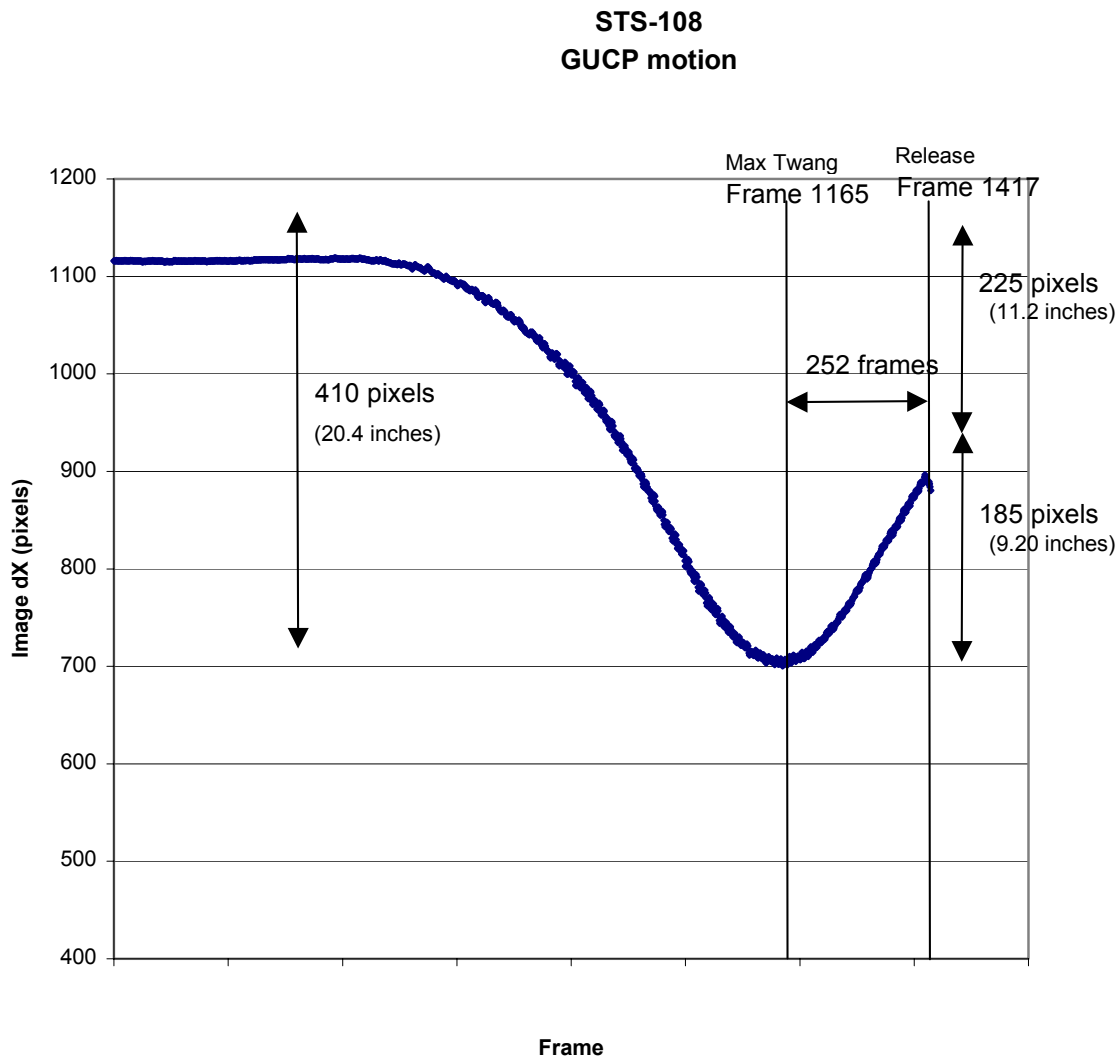
Figure 2.1.3 (B) STS-108 GUCP Motion

excluded by the fact that the STS-108 trajectory does not differ from the reference trajectories at any point by enough to indicate that any such mission unique acceleration could have occurred.

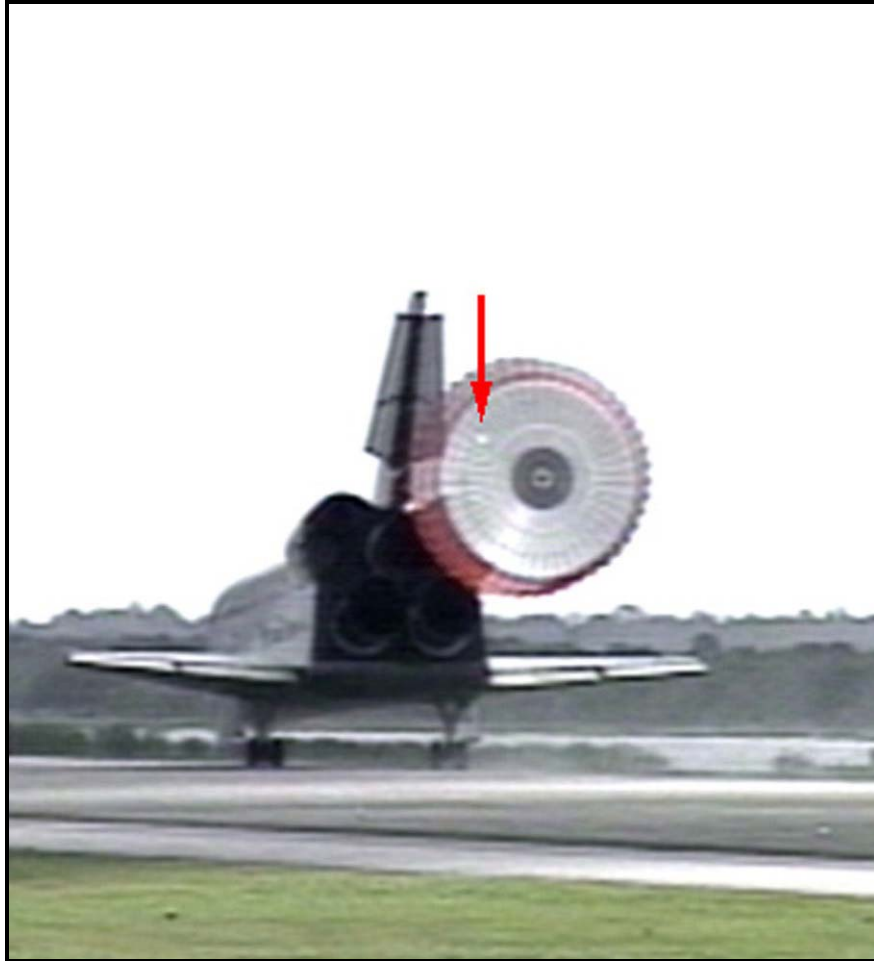
Figure 2.2.1 (A) Defect on Drag Chute Canopy

A defect (hole or tear) was visible on the drag chute canopy during the chute dis-reef until drag chute release during the landing roll-out of the Orbiter on KSC Runway 15. See Figure 2.2.1 (A). JSC engineers stated that it appeared that two of the drag chute ribbons had failed. No effect on the dynamics from the hole in the drag chute was seen on the landing imagery. A report of this finding on the drag chute canopy was sent to the Shuttle Program distribution. The anomalous drag chute event was taken to the January 10, 2002 Shuttle Program Control Board (PRCB) post-flight review.

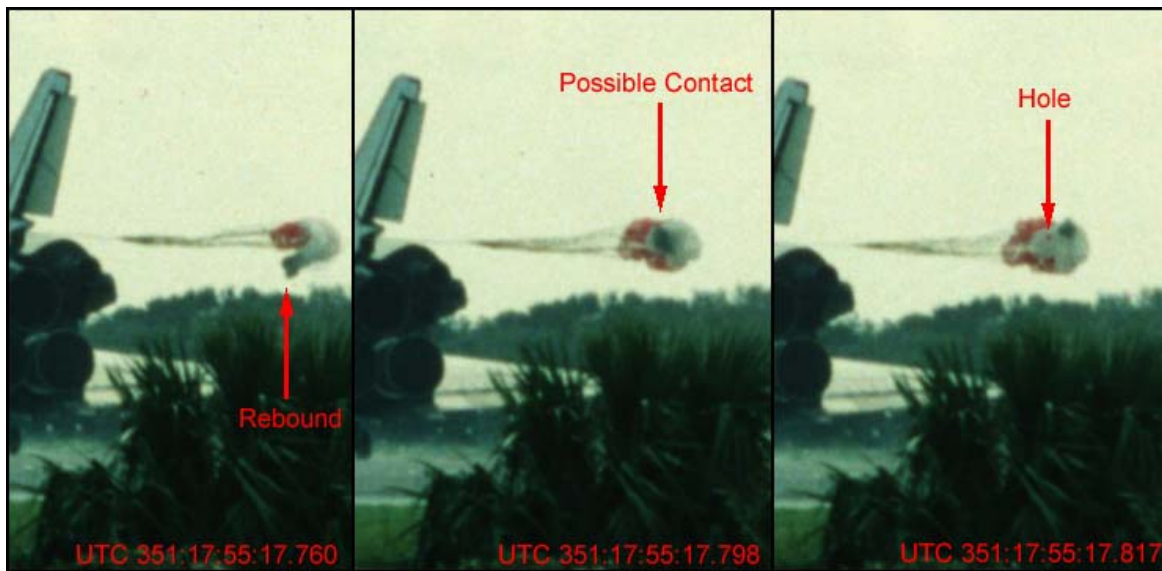
Figure 2.2.1 (B) STS-108 Drag Chute Deploy Sequence Showing Possible Hole Formation (Camera EL10)

On the STS-108 landing imagery, the tip of the drag chute was seen to rebound and contact the drag chute during the initial deploy. See Figure 2.2.1 (B). The hole in the drag chute was visible immediately after the rebound and contact.

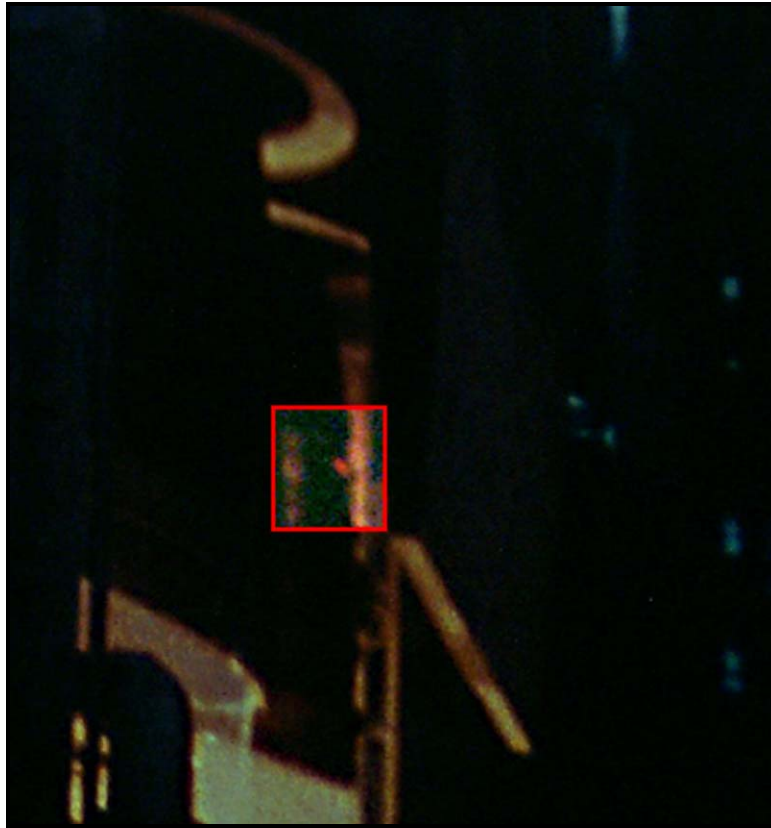
Figure 2.3.1 (A) Rectangular-shaped Debris during SSME Ignition (Camera E5)

Two unidentified pieces of red-colored debris were seen between SSME #2 / SSME #3 and the +Z side of the body flap before falling aft during SSME ignition (22:19:23.898 and 22:19:24.280 UTC). These debris pieces appeared rectangular in shape and somewhat stiff, resembling possible tags or tile shims. It is possible that this debris was RCS paper, however, they did not appear flexible and did not “float” as RCS paper debris typically does. These objects were not identified from the other camera views. (Camera E5)

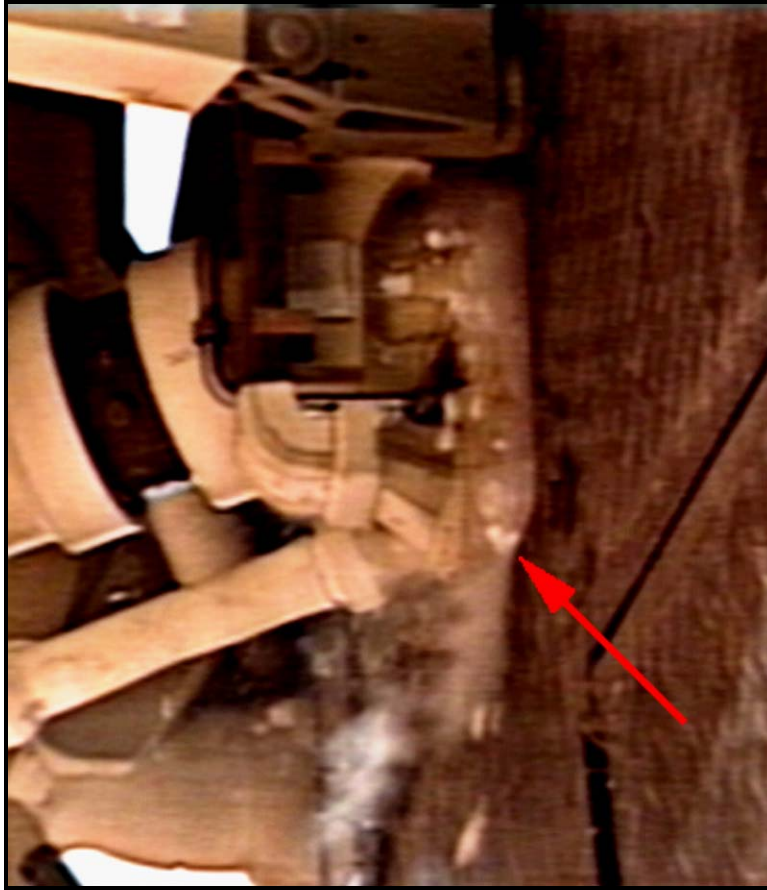
Figure 2.3.1 (B) Ice Contacts LH2 Umbilical Well Door Sill (Camera OTV109)

Multiple pieces of ice debris were seen falling from the ET/Orbiter umbilicals and along the $-Z$ side of the body flap during SSME ignition through liftoff. Six pieces of umbilical ice debris were seen to contact the LH2 umbilical well door sill during SSME ignition (22:19:23.584, 22:19:23.750, 22:19:24.151, 22:19:24.818, 22:19:25.185, 22:19:26.120 UTC). No damage to the launch vehicle was detected. See Figure 2.3.1 (B). Umbilical ice debris contacting the Orbiter surfaces has been seen on previous missions. (Cameras OTV163, OTV109, E4, E5, E18, E19, E20, E34, E36, E52, E63)

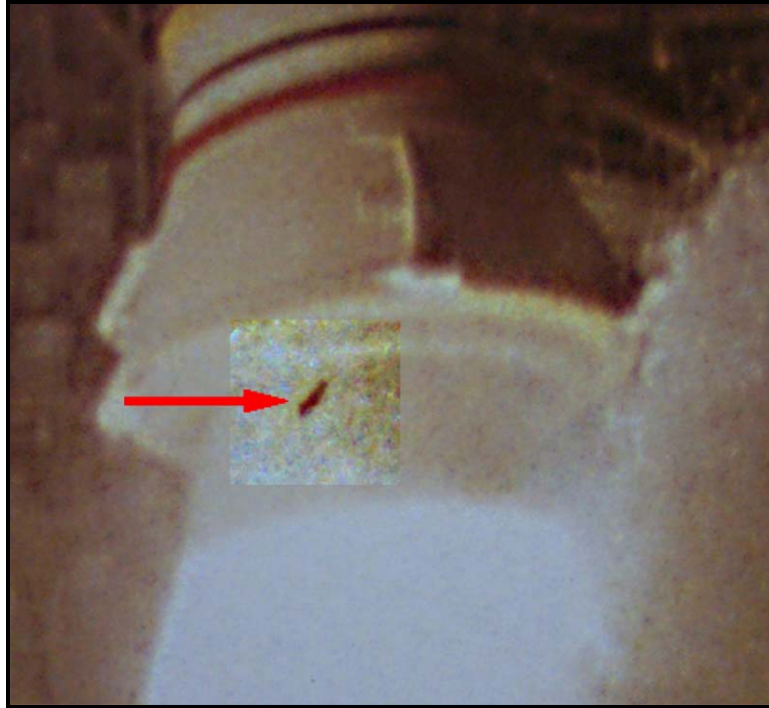
Figure 2.3.1 (C) Debris Near RSRB Aft Skirt During Liftoff (Camera E1)

Multiple pieces of SRB throat plug and/or SRB flame duct debris were seen near the right and left SRBs during liftoff. On camera E5, a light-colored piece of debris first seen on the east side of the RSRB traveled toward the $-Z$ side of the body flap before falling aft. An unidentified, light-colored piece of debris was seen near the RSRB and the ET aft dome falling aft towards the $-Z$ side of the Orbiter body flap during liftoff (22:19:28.55 UTC). (Camera OTV160) A light-colored piece of unidentified debris was seen near the RSRB aft stiffener ring moving in a $-Y$ direction beneath the ET aft dome during liftoff (22:19:28.749 UTC). Several pieces of unidentified light-colored debris (possibly SRB flame duct material) were seen moving from the vicinity of the ET toward the Orbiter near the time of liftoff (22:19:26.386, 22:19:27.788 UTC). (Camera OTV109) An unidentified, dark-colored piece of debris was first seen on the east side of the MLP near the RSRB aft skirt and moved in a northwest direction during liftoff (22:19:29.324 UTC). Also, a large, dark-appearing piece of debris was seen near the RSRB aft skirt moving in a $-Y$ direction and traveled to the north side of the LSRB aft skirt. (Camera E1) See Figure 2.3.1 (C). On camera E222, several pieces of probable SRB throat plug or SRB flame duct debris were seen near the RSRB aft skirt and moved upwards toward the trailing edge of the right wing (22:19:30.061 UTC). (Cameras E2, E222) None of this debris was seen to contact the launch vehicle.

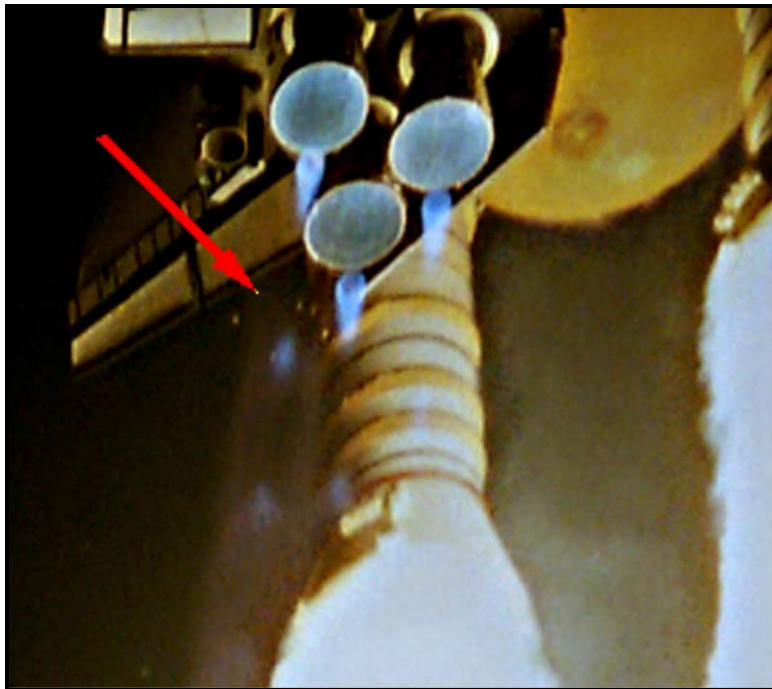
**Figure 2.3.2 (A) Spray of RCS Paper Debris Seen Aft of Left Wing During Ascent
(Camera E52)**

Multiple pieces of debris, too numerous to count (mostly umbilical ice and RCS paper debris), were seen falling aft of the launch vehicle during ascent. See Table 2.3.2 (A).

22:19:39.549 and 22:19:40.344 UTC	Multiple pieces of RCS paper debris seen near left wing (E52) See Figure 2.3.2 (A).
22:19:43.45 UTC	RCS paper debris seen near the aft end of the launch vehicle (Camera ET207)

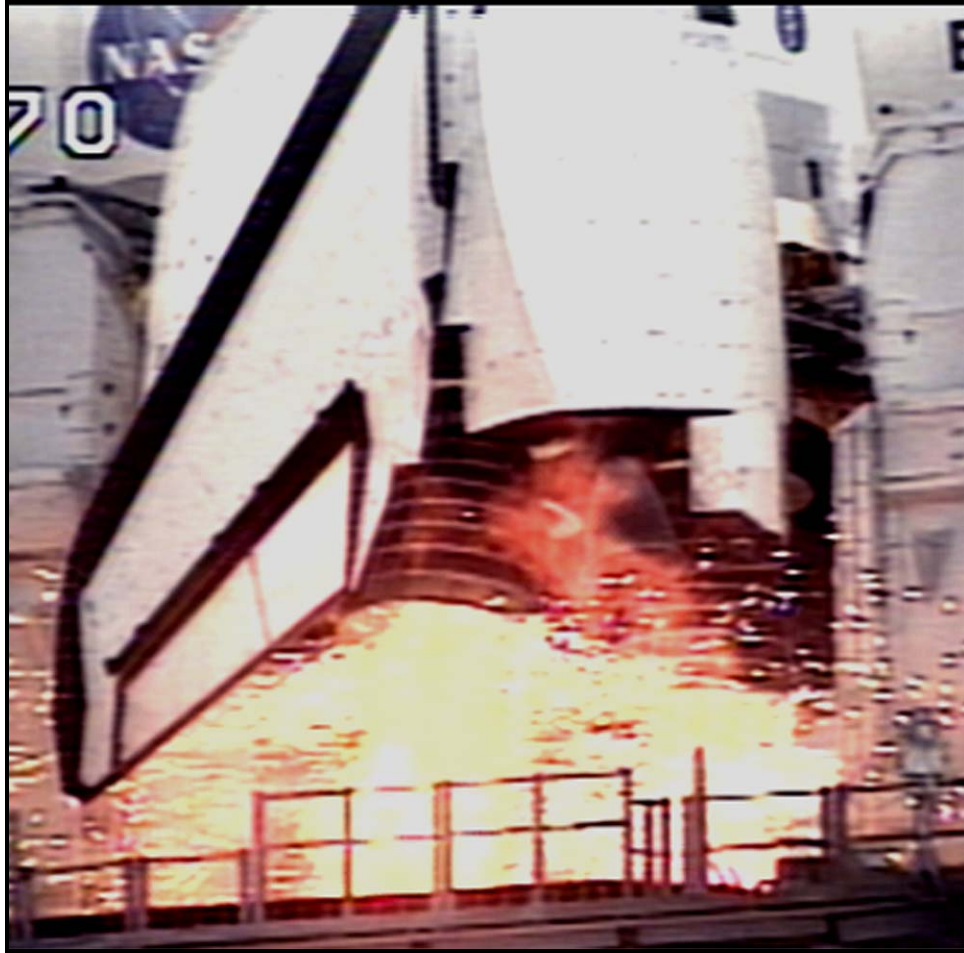
**Figure 2.3.3 (A) Orange Vapor Seen Above SSME Rims Prior to Liftoff
(Camera OTV170)**

Orange vapor (possibly free burning hydrogen) was seen forward of the base of the vertical stabilizer, near the base heat shield, forward of the trailing edge of the OMS pods, and on the -Z side of the body flap during SSME ignition. Orange vapor forward of the aft end of the Orbiter during SSME ignition has been seen on previous mission films and videos. (Cameras OTV170, E1, E2, E4, E17, E19, E20, E36, E52, E63, E76)

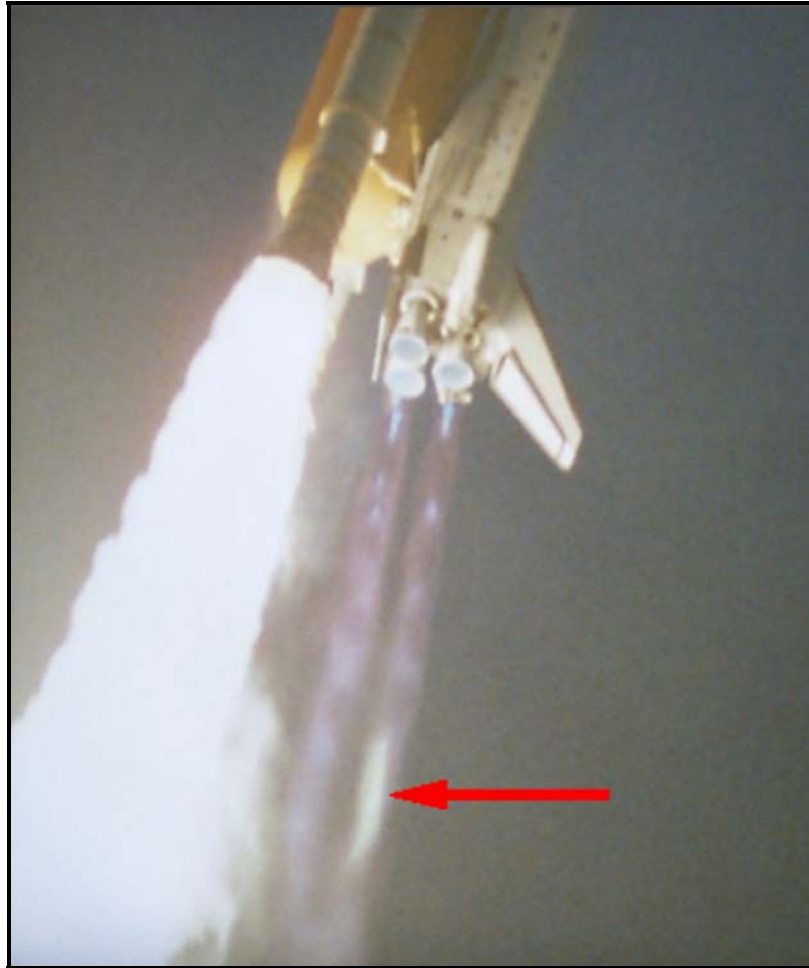
Figure 2.3.4 Flare Seen in SSME Exhaust Plume (Camera E222)

Multiple light-orange-colored flares (possibly debris induced) were noted in the SSME exhaust plume during ascent on the long range tracking camera films. Often on previous mission imagery, debris has been seen contacting the SSME exhaust plume resulting in visible flares. Usually this debris was RCS paper. (On STS-26 and STS-101, debris that resulted in very large orange-colored flares was determined to have been tile material.) Examples of flares seen on STS-108 can be seen in Table 2.3.4:

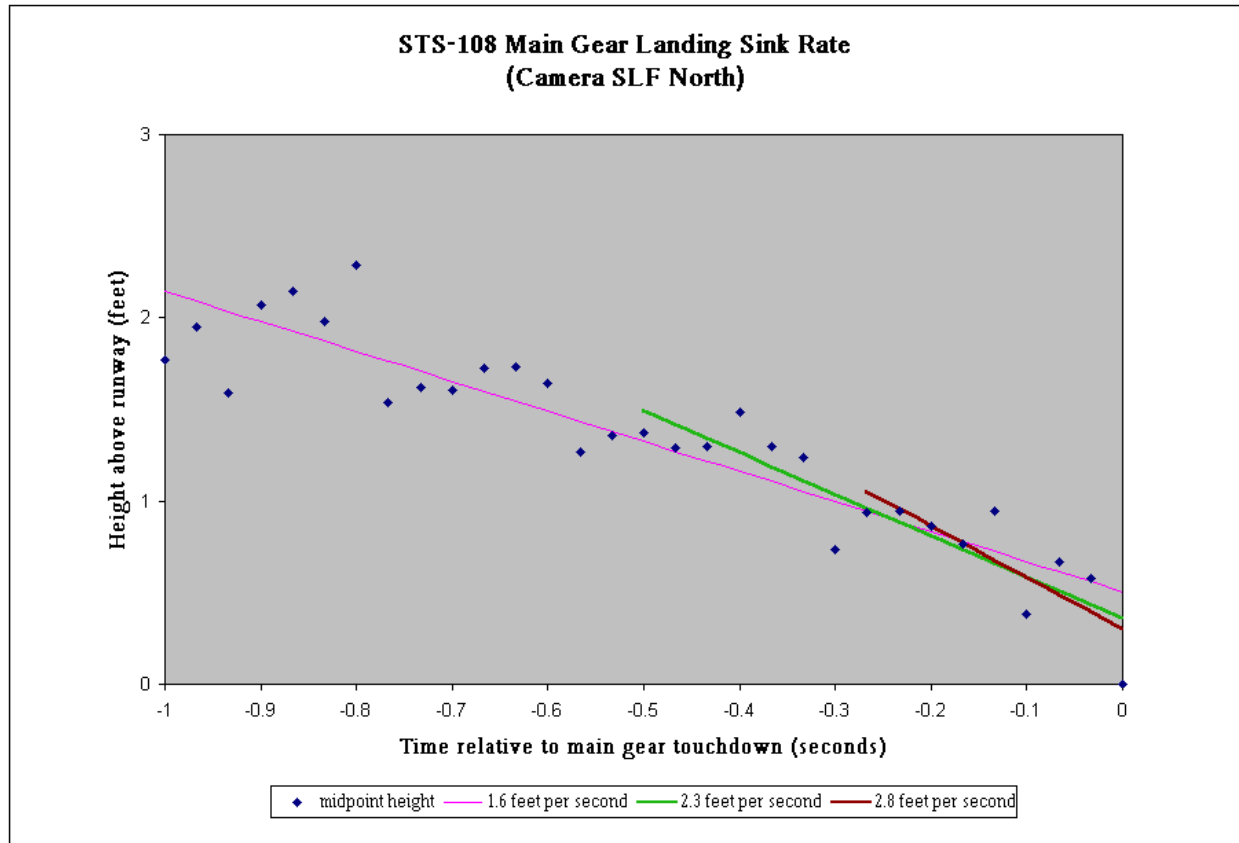
Figure 2.6 (B) Main Gear Midpoint Landing Sink Rate

The maximum allowable main gear sink rate values are 9.6 feet / second for a 212,000 lb. vehicle and 6.0 feet/second for a 240,000 lb. vehicle. The landing weight of the STS-108 vehicle was reported to be 226,442 lbs.

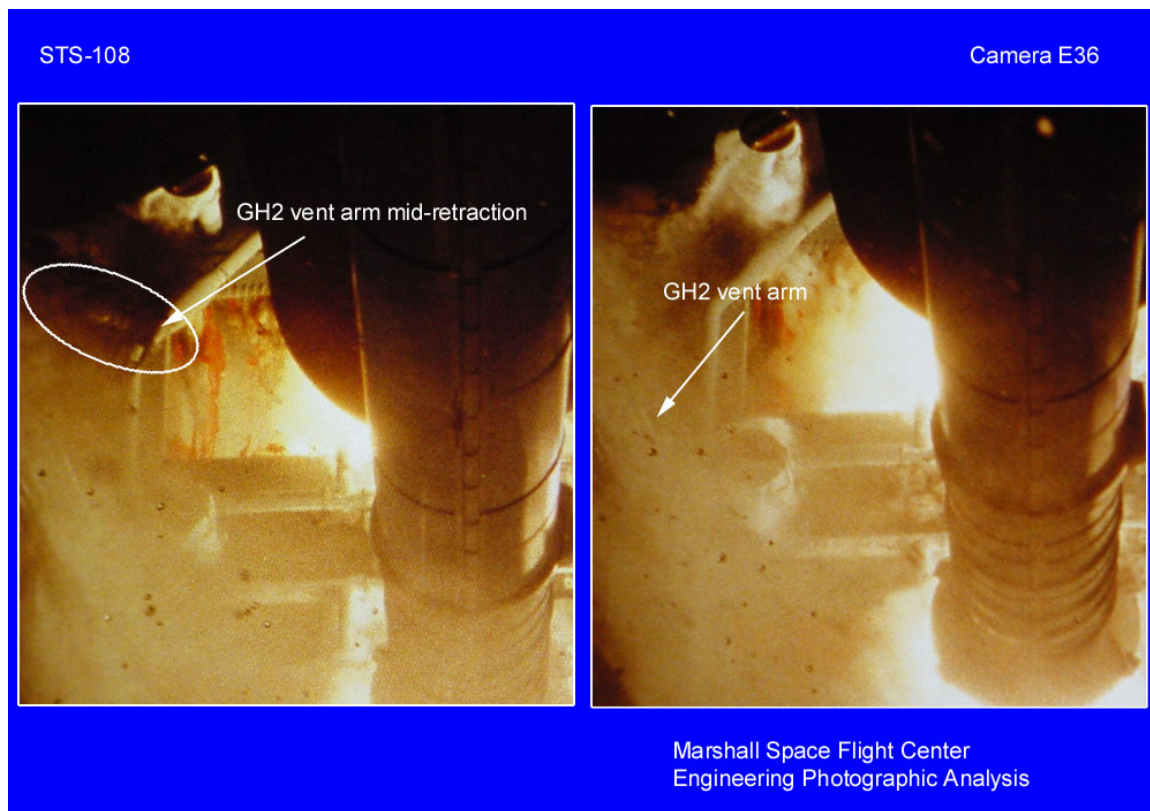
Figure 1. Film Camera E36: GH2 Vent Arm Retraction

Image Screening - The Gaseous Hydrogen (GH2) vent arm was seen to contact the south side of the support structure at, or near, the saddle plate. A large-appearing piece of dark-colored debris was seen falling almost vertically downward toward the left SRB flame trench as a result of the vent arm contact. The vent arm did not latch-back and the Gaseous Umbilical Carrier Plate (GUCP) was seen to rebound beyond the Fixed Service Structure (FSS) a distance equal to approximately one half the length of the GUCP (estimated to be a distance of approximately one foot). See Figure 2.1.1. The left SRB was the closest part of the launch vehicle to the vent arm during the rebound; however, the rebound motion did not bring the GH2 vent arm significantly close to the launch vehicle. Using the left SRB for scaling (the SRB diameter equals 12 feet), it appeared that the distance between the vent arm at the point of maximum rebound and the left SRB was at least thirteen to fifteen feet during liftoff. Neither the rebounded vent arm / carrier plate nor the debris from it's FSS impact was observed to contact the launch vehicle. The GH2 vent arm retraction appeared normal on the camera views. No excessive slack or other unusual
